MARINE INVESTIGATION REPORT
M01C0033

TAKING ON WATER AND SINKING

AMPHIBIOUS VEHICLE *LADY DUCK*
OTTAWA RIVER
30 JUNE 2001

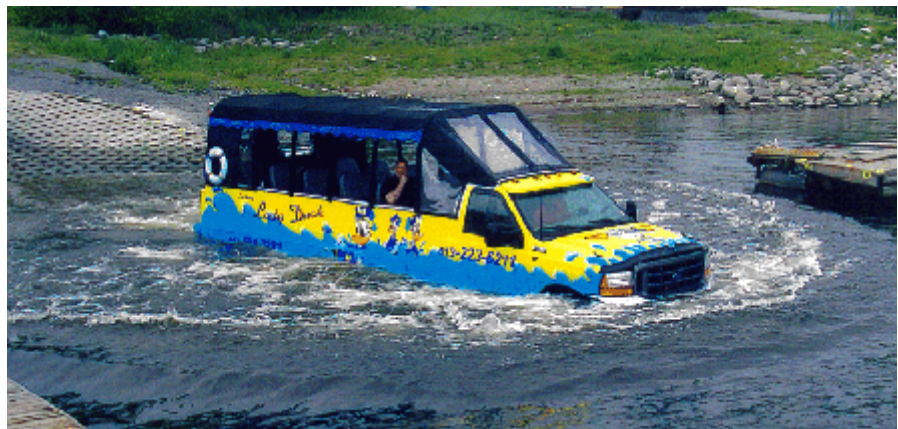
Photograph 1. *Lady Duck* entering the water at Hull Marina.

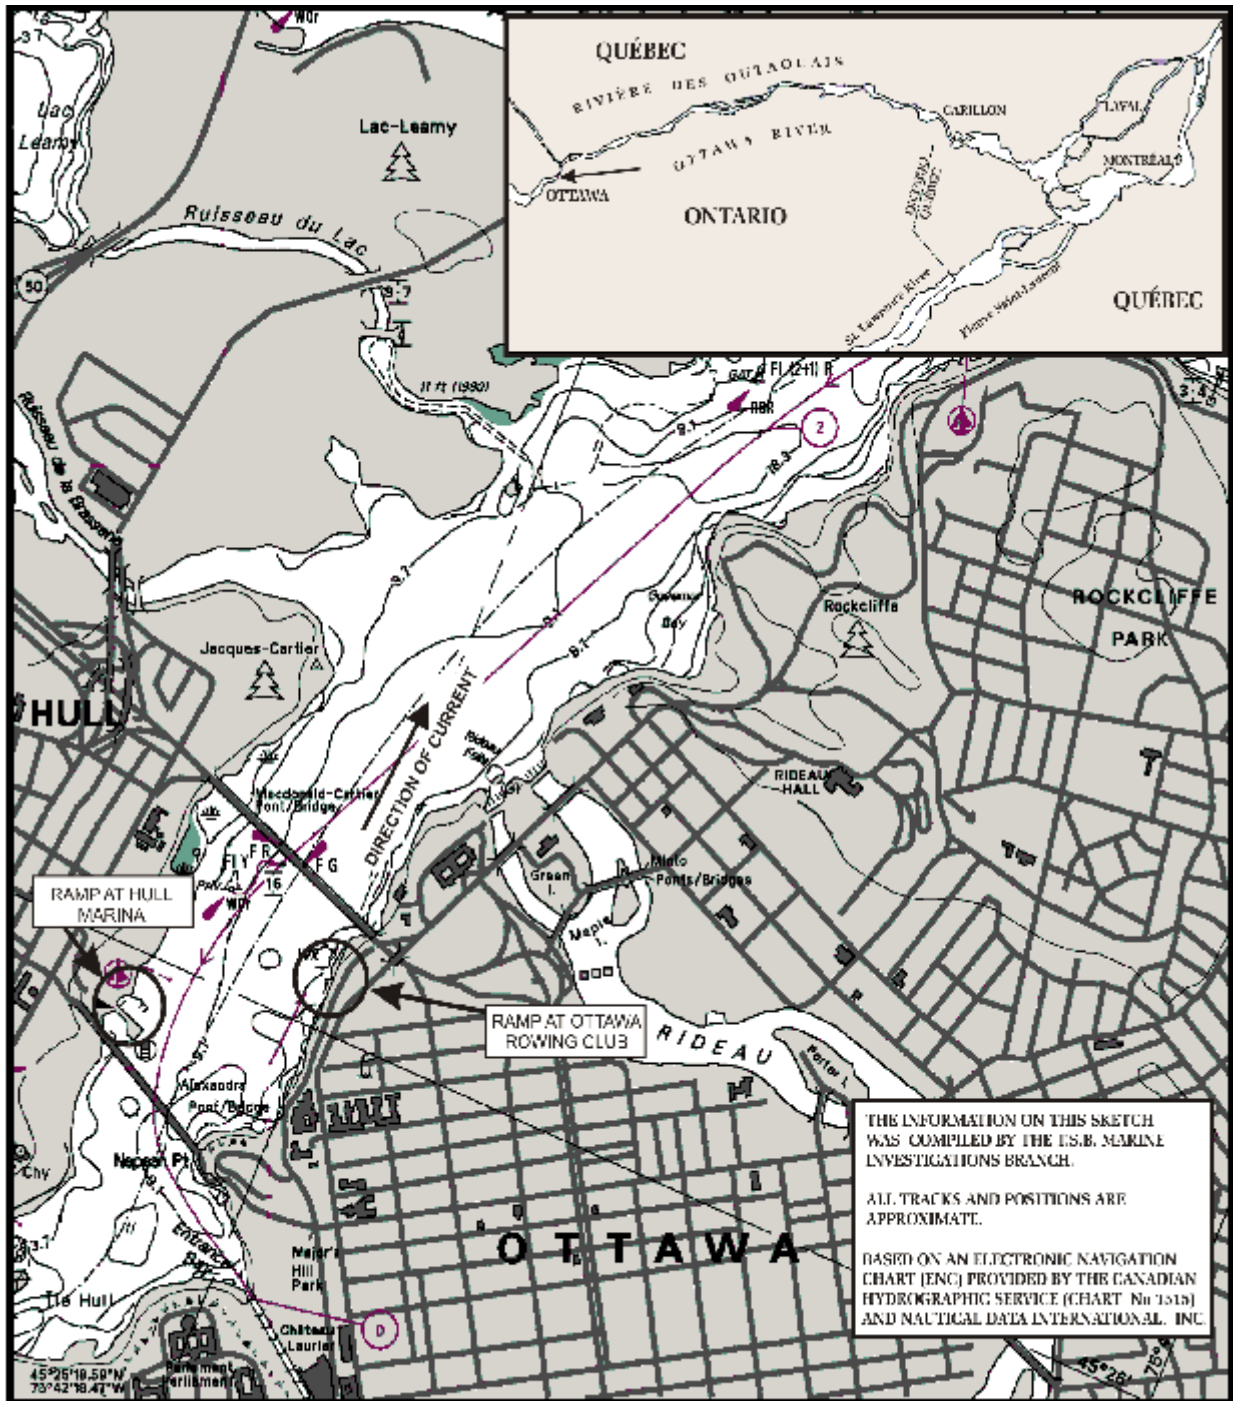
Appendix A: Sketch of Occurrence Area

When close to the ramp, GCU-480 was disengaged to enable the *Lady Duck* to make the left turn necessary to align the vehicle with the centreline of the ramp. However, because the damaged steering controls and the marked forward trim made manoeuvring difficult, the final approach was not directly in line with the ramp's central axis. The front right wheel became grounded on the left edge of the ramp, with the vehicle aligned some 45° to the left of the ramp axis.

As attempts were being made to drive the *Lady Duck* out of the water, the front right wheel of the partially flooded vehicle grounded on the left edge of the ramp. The forward momentum and the grounding effect slightly raised the front right side of the vehicle, and the floodwater in the hull surged to the left side. This transfer of weight caused the vehicle to heel to the left and ship more water over that side. The additional shipped water downflooded into the hull and caused the *Lady Duck* to suddenly capsize and sink.
